Central Corridor Performance Monitoring Report 2016

Promoting efficiency in transport, logistics value chain and trade in the region

April 2017

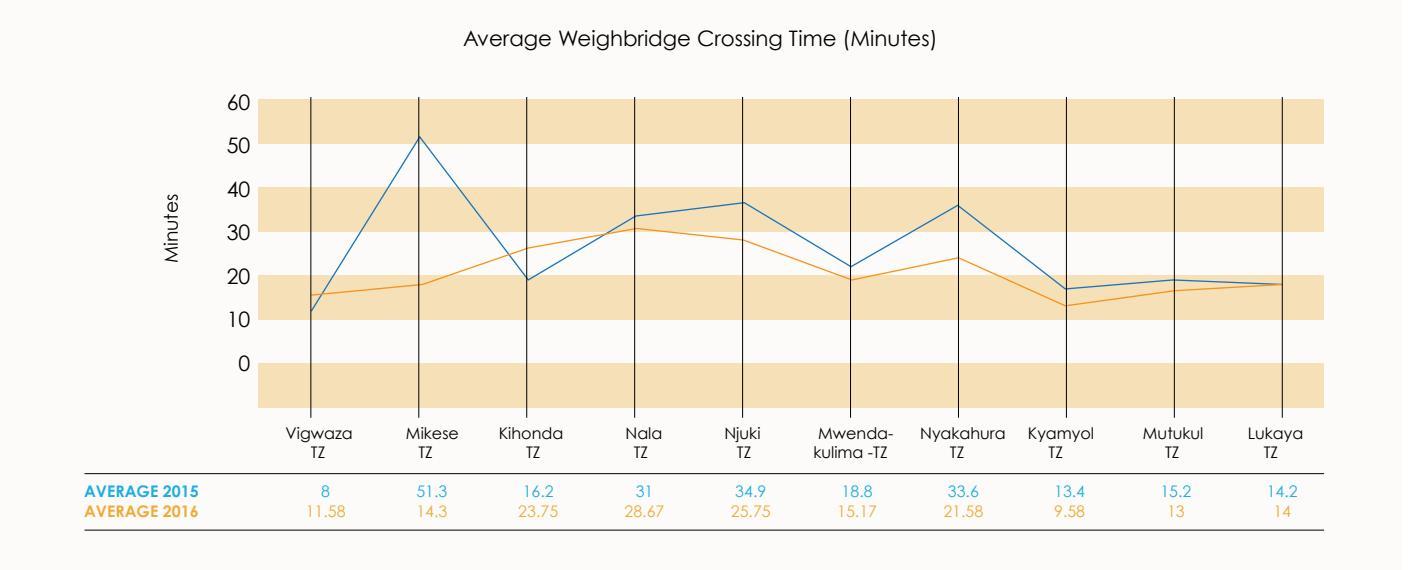
Figure above indicates average crossing time at various weighbridges along the Central Corridor. Weigh in motion at Vigwaza (Coast) and Mikese (Morogoro) both in Tanzania have shown massive reduction in the weighbridge crossing time after being converted into weighs in motion; they're among the three weighbridges that attract less crossing time compared to all other weighbridges. This is due to the fact that trucks weigh while moving. The congestion and weighbridge crossing time has significantly been reduced compared to the previous static weighbridge. The removal of Police check points at Mikese has also helped to reduce stoppage time.

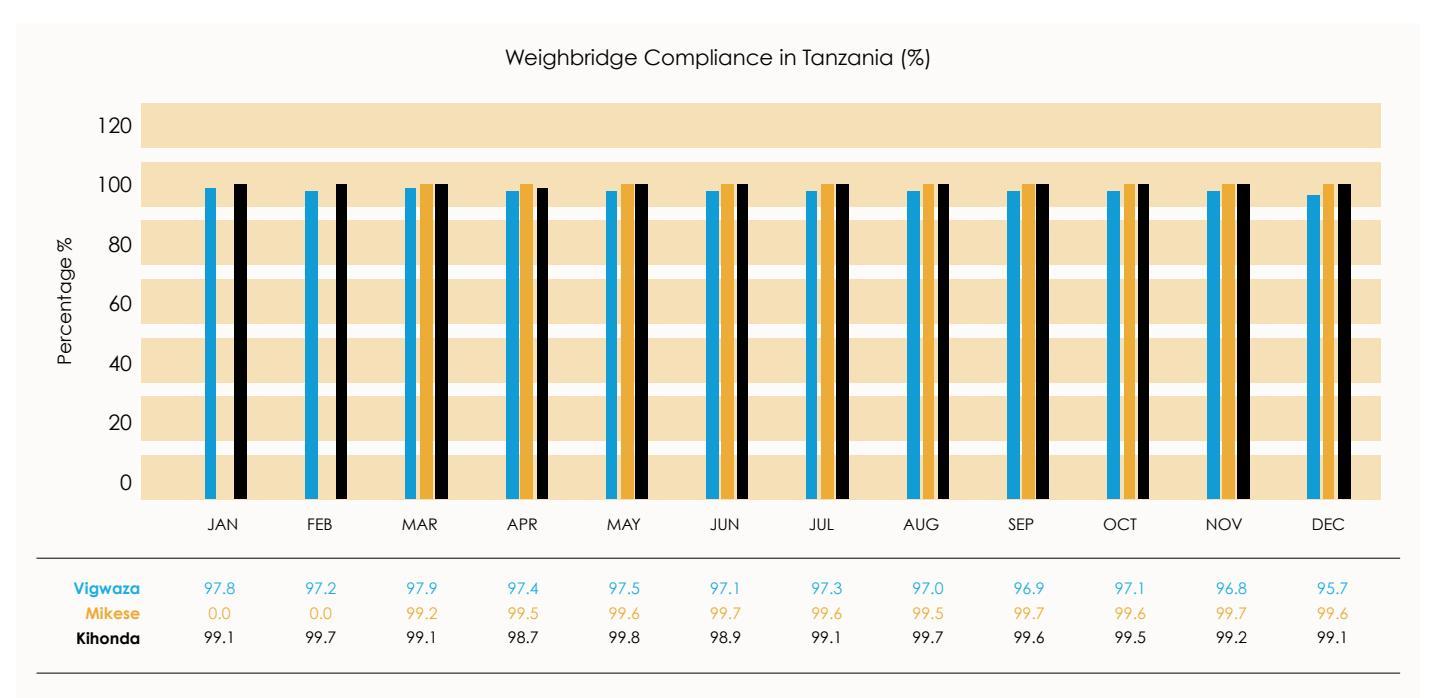
Figure 4: Weighbridges Compliance

The figure above shows that there is high compliance level by trucks in all three weighbridges. The compliance is consistent throughout the reporting period (January to December 2016). The average compliance is at 98.8%.

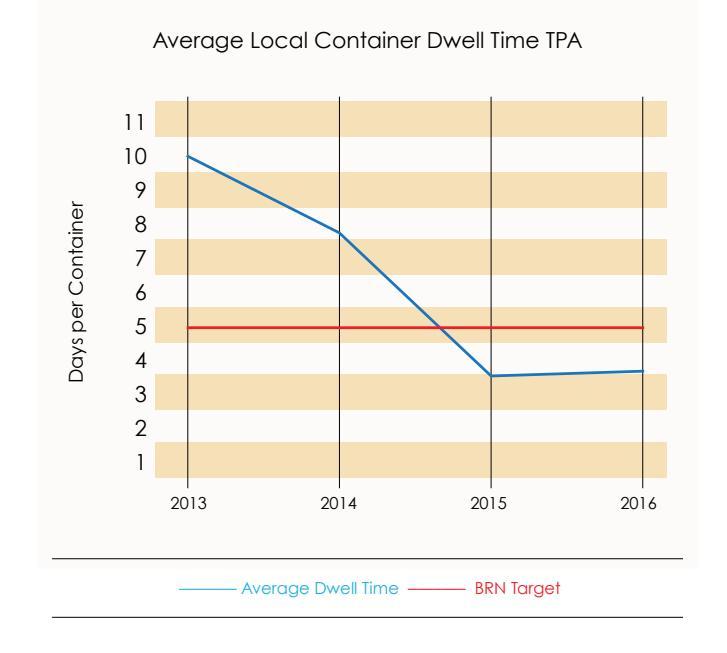
Figure 5: TPA average local container dwell time 2013-2016

It is clearly observed that the average dwell time for local containers is 9.94 days for 2013, 7.74 days for 2014, 3.58 days for 2015 and 3.73 days for 2016, this shows that according to BRN Target of 5 days, the local dwell time from 2015 has attained the expected target.

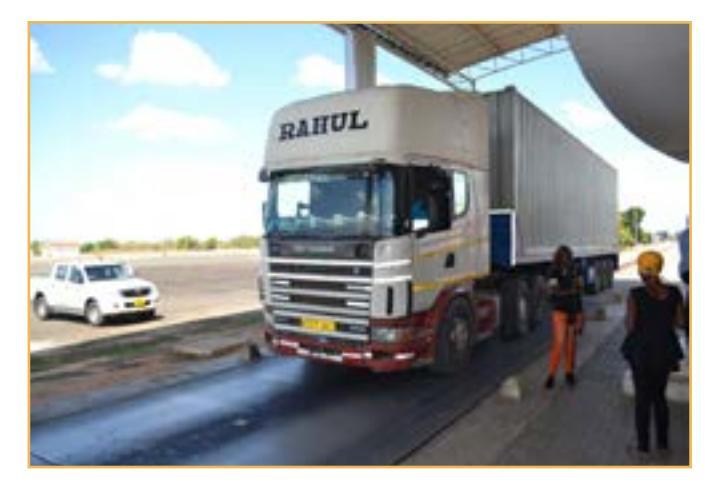
The 2016 Routes survey observed however that only about 5% of trucks had stickers leaving 95% of the trucks weighing in all the weighbridges. Trucks with stickers can save more than 70% of the weighbridges crossing time. While drivers see the benefits of weighing at three weighbridges, the truck owners feel the cost of stickers is a burden to them as the transit trucks are clearly identifiable. The issues were discussed during the TTFA organs meeting on August 2016 and the Ministry of Works, Transport and Communication, Tanzania committed to evaluate and come up with a way forward.

Vigwaza Weighbridge is the first from Dar es Salaam for both transit and local trucks.

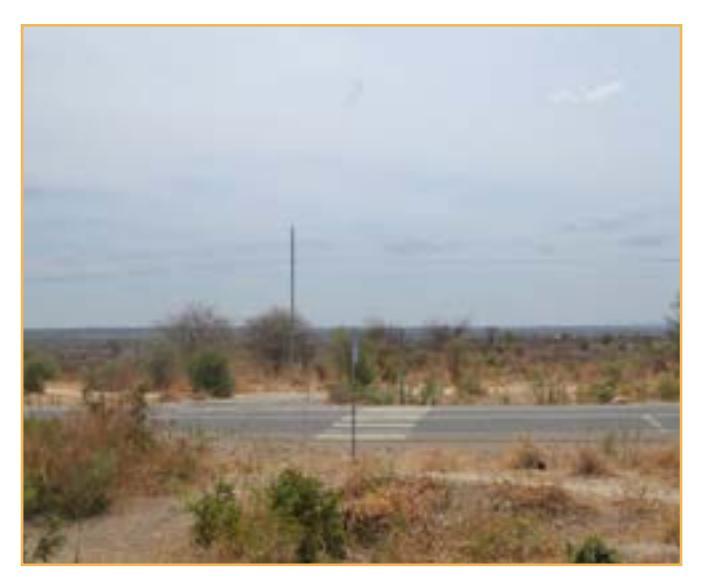
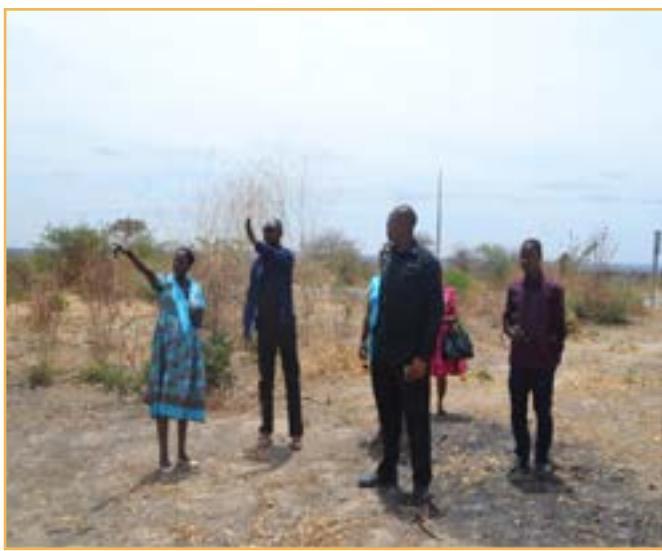
Site for construction of Manyoni One Stop Inspection Station (OSIS) as was seen during the December 2016 route survey.

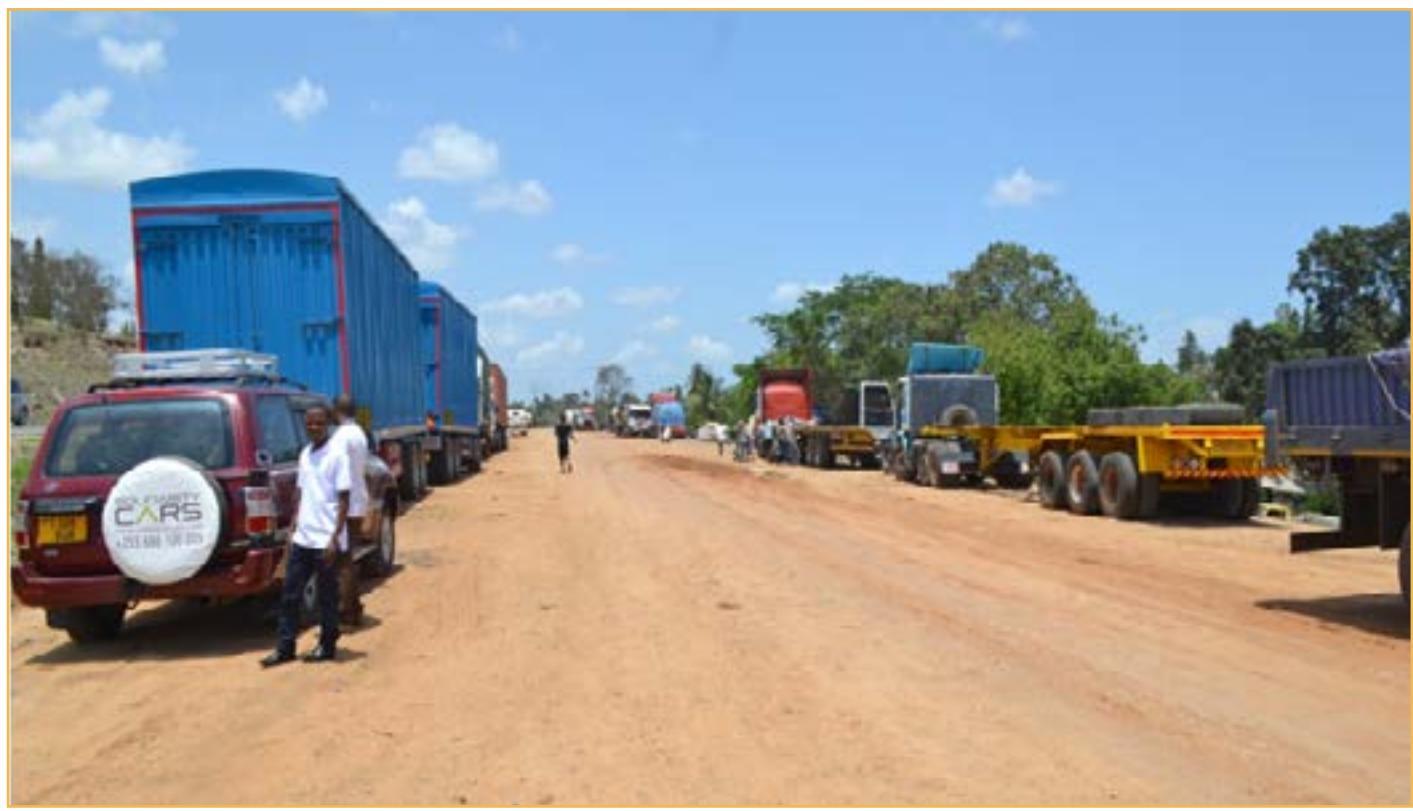
Mbezi truck parking area

Due to congestion especially during rush hours in the morning, government decided that all trucks heading to the city are kept at Mbezi holding area during the period of (0500 - 0930hrs). Trucks which stay there beyond 0930hrs are charged a parking fee of 500 Tshs/hour between 0930 - 1700hrs by the local government authority. Also, trucks leaving the city are encouraged to leave during the early morning in order to dodge congestion during the morning and evening rush hours. With presence of UDART Rapid bus services from City Centre to Kimara, the section has been slightly relieved of congestion. The section between Kimara Mwisho and Kibaha need expansion and improvement of the surface.

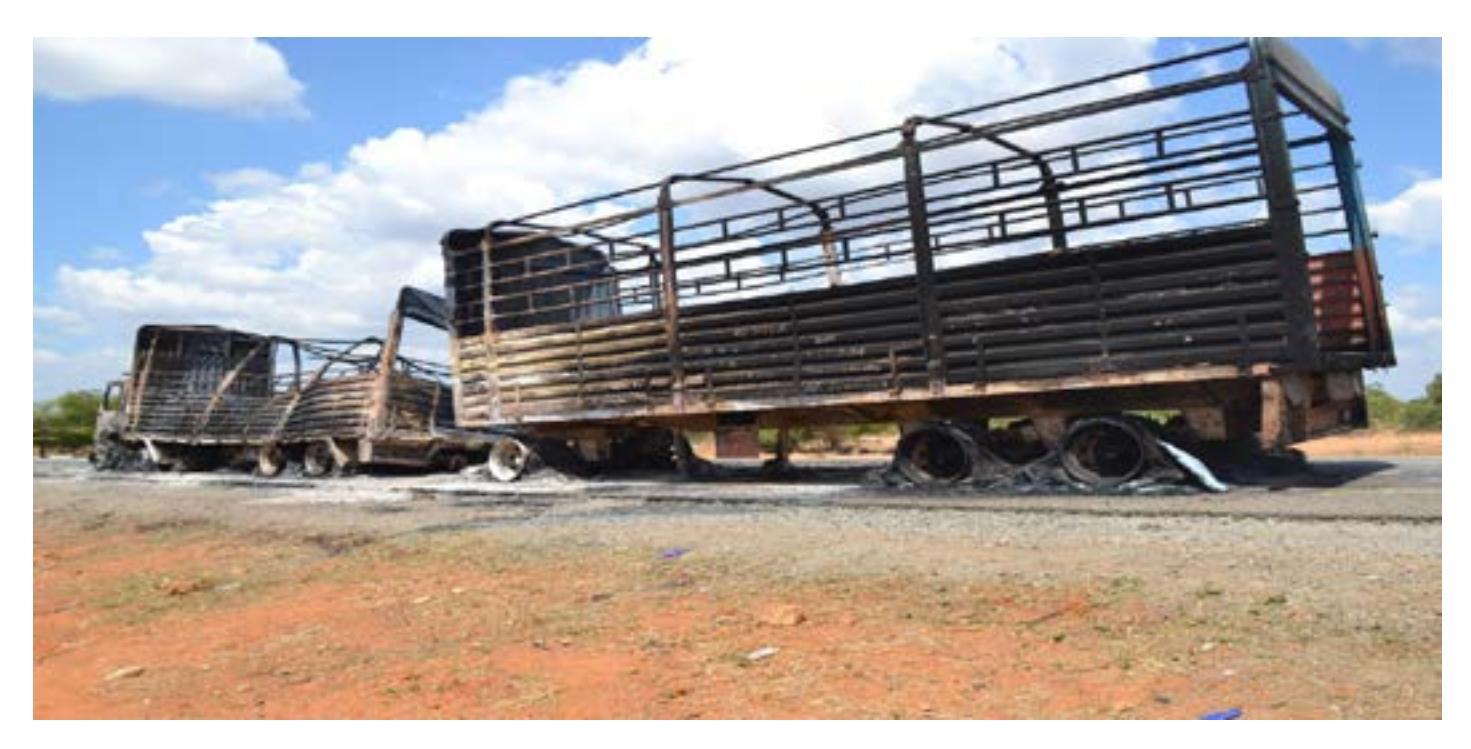
Truck carrying goods burnt completely at Manyoni in December 2016 due to lack of firefighting services

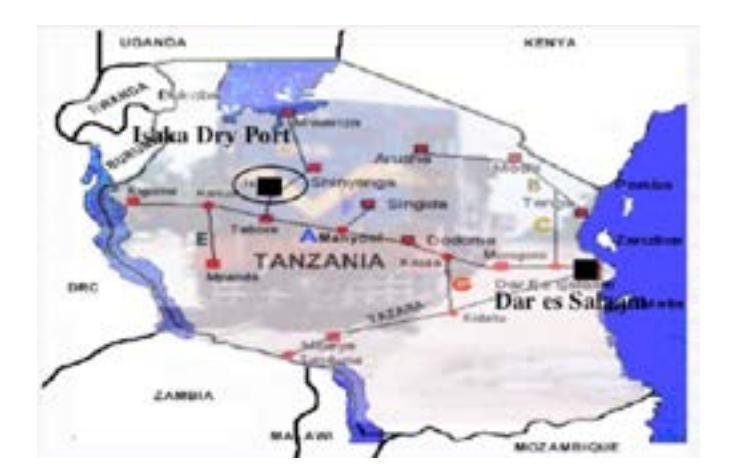
The Isaka dry port is an extension of Dar es Salaam port, situated at Kahama district in Shinyanga region about 950km from Dar es Salaam. The dry port is connected by railway from Dar es Salaam. Its total area is 11.04 hectares with Stacking area of 12.350 square meters paved and can handle 13,000 TEUS per annum. The facility can handle 42, 583 MT tones cargo per year in two transit sheds.

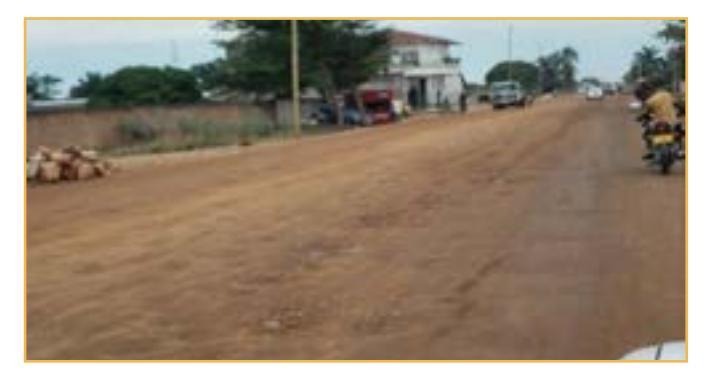
The road section of Nyamitanga-Ruhwa (48 km) Burundi and Rwanda was constructed under AfDB funds as an International road Nyamitanga-Ruhwa (Burundi)/Ruhwa-Ntendezi Mwityazo (Rwanda) and was the first road to be constructed in Burundi under EAC standards. The road signs are standardized and still in good condition. However, road signs are not observed by road users due to failure to enforce the same by police.

The missing link of Bujumbura-Nyamitanga (32km) which is currently in very poor condition. It is under tendering evaluation and tender documents were opened on 19/12/2016 where construction is expected to commence by early 2017.

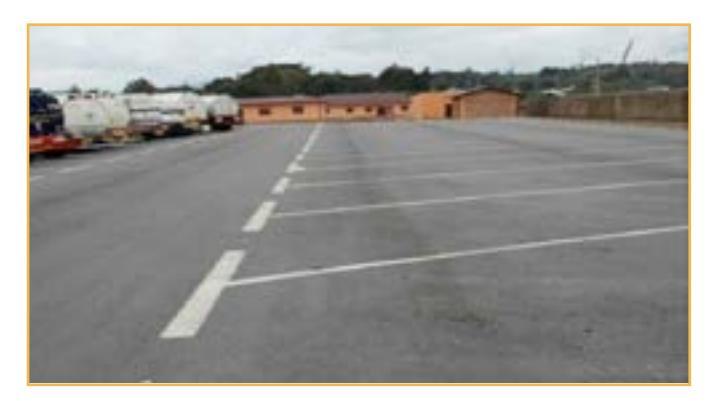
The truck parking of Gitega was built by the Burundi Roads Office under AfDB funding. The purpose of the parking is to accommodate the trucks in transit to Bujumbura and the trucks awaiting for customs clearance in Gitega. The parking's building is equipped with a weighbridge. There is a need to enhance the wall to secure the parking. The management of the parking of Gitega has been entrusted to the Burundi Revenue Office (OBR) which henceforth works in parking's installations. Parking rates in both Gitega and Bujumbura parking are harmonized at 14,000 BIF (8\$) per night for a loaded truck and 3,000 BIF (2\$) per night for an empty truck.

New trucks Parking Facility in Gitega built under AfDB funding.

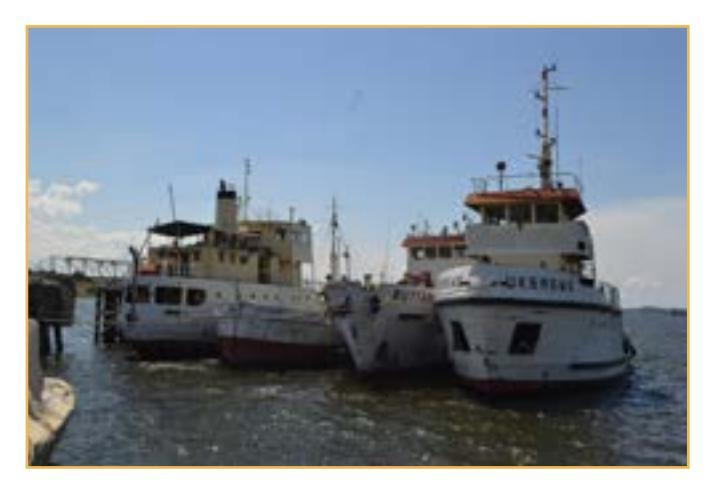
The vessels owned by MS in Lake Victoria include M/V Sangara (tanker), M/V Clarias, M/V Serengeti, M/V Umoja, M/V Victoria, M/V Butiama. In Lake Tanganyika, the MS owns M/V Liemba, M/V Sangara and M/V Mwongozo and in Lake Nyasa there are M/V Songea and M/V Iringa. Out of 14 Vessels owned by MS only 3 were operational as of December 2016, operational (M/V Umoja in Mwanza, M/V Iringa of Nyasa and M/V Liemba of Kigoma. They have floated tender for maintenance of M/V Liemba, M/V Victoria and M/V Butiama. Lack of workshops for maintenance of vessels. Workshops are owned by TPA and MS feels if they could own them it could be easier for them to use. The government is planning for a new Vessel with capacity to handle bigger volumes of passenger and cargo.

As of December 2016, most of these vessels were grounded

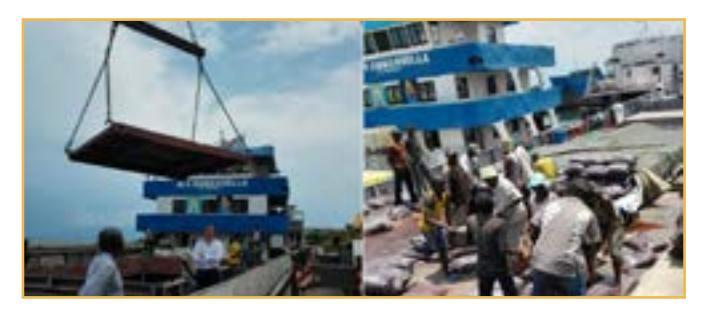
Complete contrast at Kalundu Port! From manual handling of goods (right) to machine handling of goods (left) thanks to a new crane installed at the Port.
